MANDATORY SERVICE BULLETIN

EFFECTIVITY: BELL 206 & 206L SERIES HELICOPTERS EQUIPPED WITH AIRFILM CAMERA SYSTEMS G1 UTILITY MOUNT

SUBJECT: MANDATORY INSPECTION AND MODIFICATION OF NOSE CONSOLE AT G1 MOUNT FASTENERS

DATE: 1/05/2015

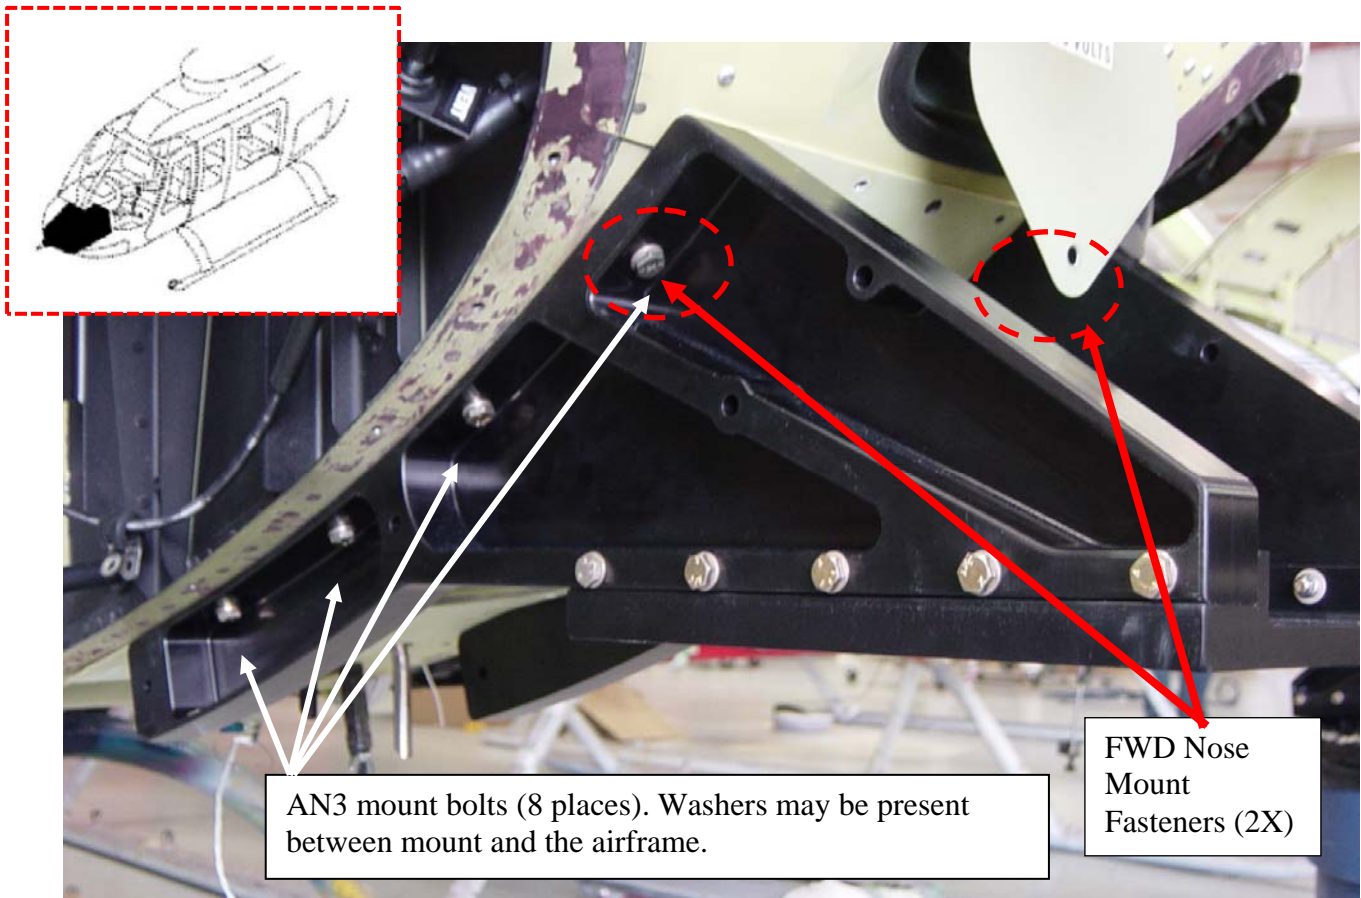
Figure 1 G1 Mount Fastener Locations

- (1) Remove G1-1 Utility Mount to gain access to the Internal Nose Console (airframe) by removing the 8 AN3 mounting bolts on the outboard upper flanges of the G1 Mount. Reference Install Instruction (AF-G1-006) for detailed description of removal procedures.

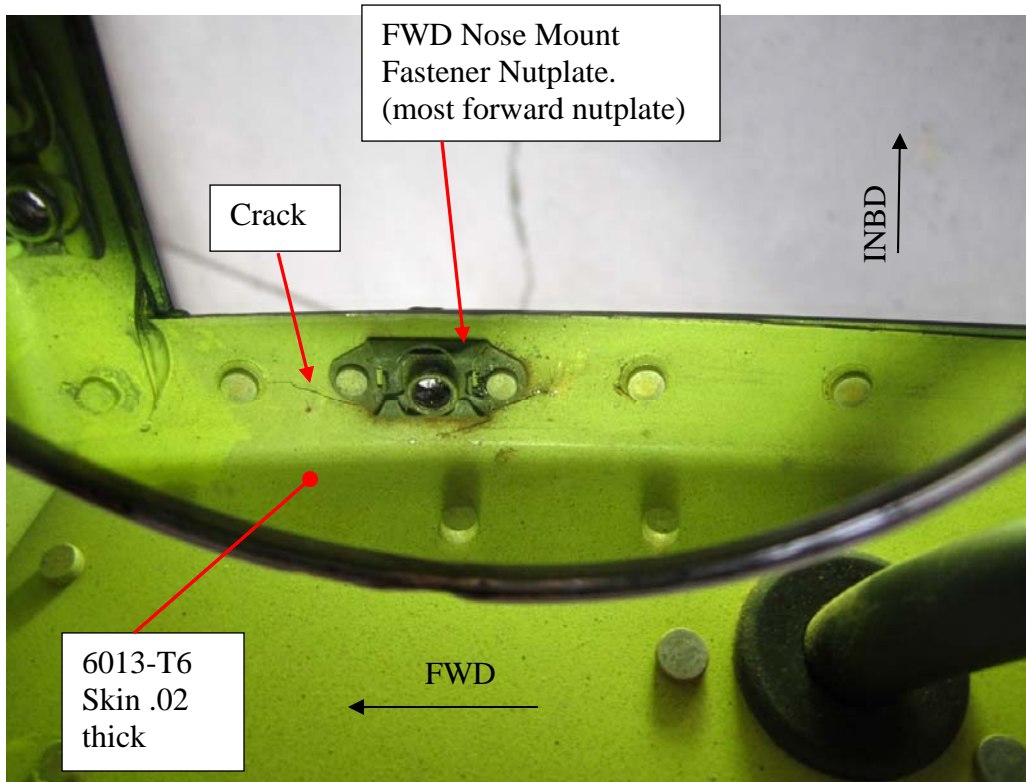
Figure 2 View (looking Down) Showing the LH Side Forward Fastener with Crack Damage

- (3) Inspect for cracks in the Nose Console area at the G1 mount forward fastener nutplates (RH & LH sides). Figure 3 shows a typical crack near the nutplate at the radius of the formed flange.

Use 10X magnified visual inspection or fluorescent penetrant inspection (per ASTM E1417) to inspect for cracks in the areas noted.

- (4) If no cracks are found, proceed to step 5. If cracks are present, repair in accordance with Airfilm Drawing AF-G1-300.

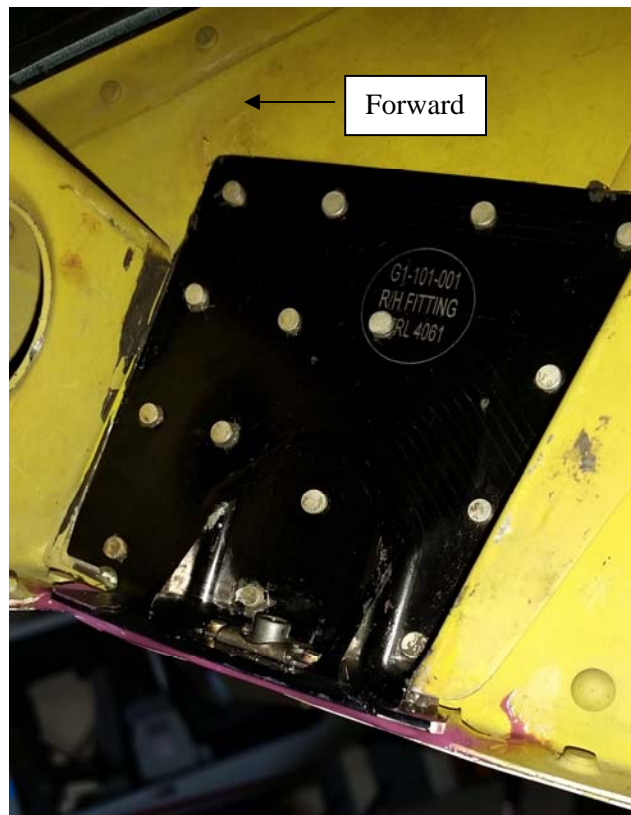
Figure 3 View Showing the Repair Fitting Installed (RH Side)

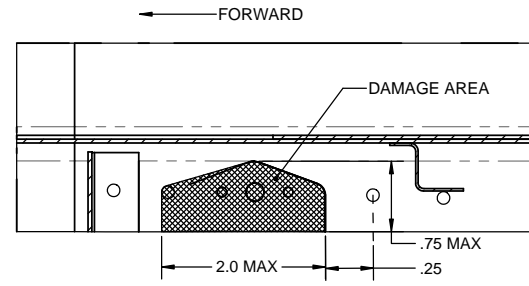
**SECTION B-B
DOUBLER FITTING REMOVED TO SHOW DAMAGE LIMITS**

1. REMOVE RIVETS IN REPAIR AREA
2. REMOVE DAMAGED FLANGE BY CUTTING/GRINDING.
3. ALL INTERNAL RADII .125 MIN.
4. POLISH CUT SURFACES, 63 RHR MAX (MILL FINISH).
5. INSPECT DAMAGE AREA AND ADJACENT RIVET HOLES USING 10X MAGNIFIED VISUAL INSPECTION OR FLUORESCENT PENETRANT (PER ASTM E1417).
6. FABRICATE SHIM FROM .016 THICK 2024-T3 CLAD PER AMS-QQ-A-250/5.
