MANDATORY SERVICE BULLETIN

EFFECTIVITY: BELL 206 & 206L SERIES HELICOPTERS EQUIPPED WITH AIRFILM CAMERA SYSTEMS G1 UTILITY MOUNT

SUBJECT: MANDATORY INSPECTION AND MODIFICATION OF NOSE CONSOLE AT G1 MOUNT FASTENERS

DATE: 1/05/2015

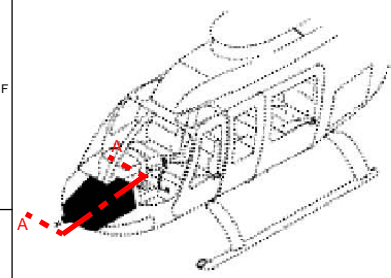
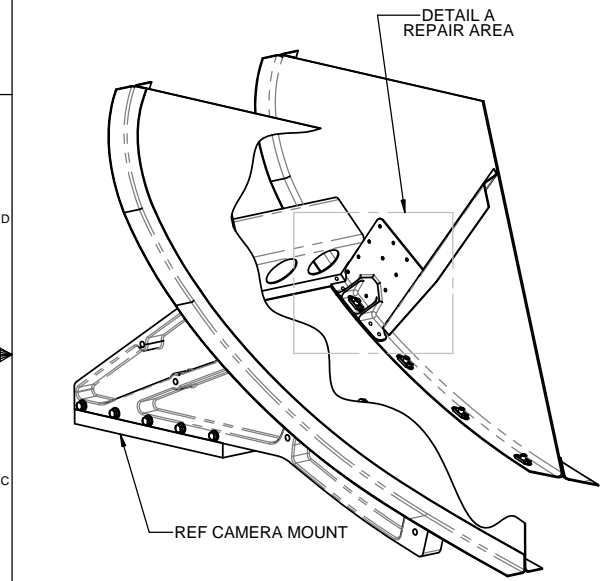
NOSE VERTICAL SUPPORTS AND BULKHEAD VIEW LOOKING FORWARD

SPOTFACE REPAIR FITTING RADIUS FOR RIVET BUCKTAIL - AS REQUIRED

INSTALL SHIM A/R TO ALLOW DOUBLER TO INSTALL ON TOP OF STIFFENER FLANGE

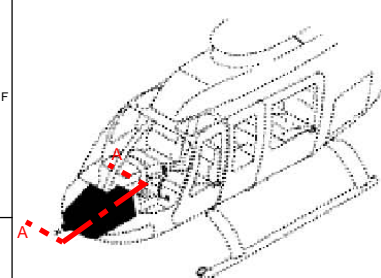
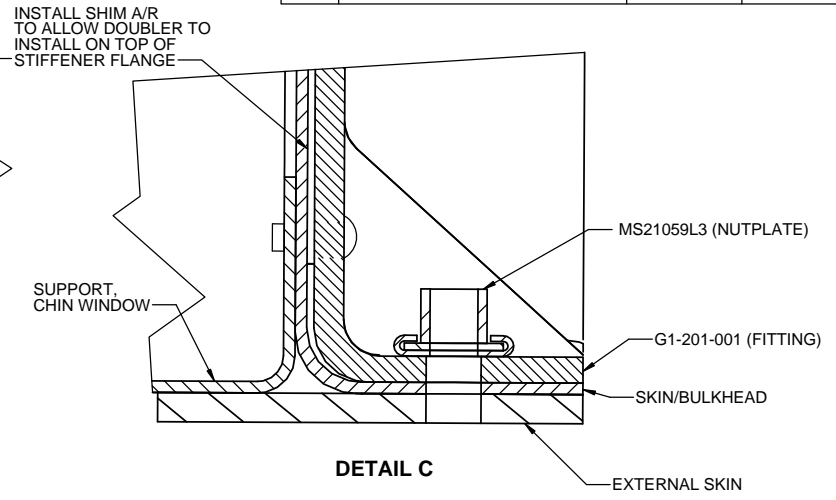
DETAIL A
RH SHOWN (LH SIMILAR)

SPOTFACE REPAIR FITTING RADIUS FOR RIVET BUCKTAIL - AS REQUIRED
